VWP INSPECTION CHECKLIST

Project Name Region 2000 Regional Landfill -Livestock Rd Facility	VWP Permit # 14-1361	Inspection Date 6/18/2019
Inspector Name Shawn Crist	Phone # & Email Address 434-316-4031- shawn.crist@deq.virginia.gov	
Address or lat/long (if no permit no.) 37.279167/-79.149167	Others Present During Inspection Jay Roberts-DEQ, Robert Arthur-Region 2000, William Salomone-DAA, Clarke Gibson-Region 2000	
Project Phase: <input type="checkbox"/> Pre-Construction <input type="checkbox"/> Ongoing Construction <input checked="" type="checkbox"/> Final Stabilization <input type="checkbox"/> Complete <input type="checkbox"/> Other _____	Reason for Inspection: <input checked="" type="checkbox"/> Compliance – Construction / Impacts <input type="checkbox"/> Complaint <input type="checkbox"/> Compensation <input type="checkbox"/> Enforcement Follow-Up

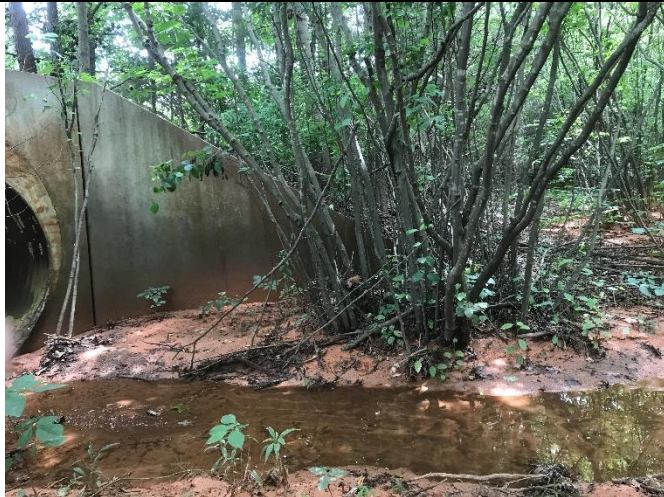
Photo 1	Impacts at 72-inch Culvert	Photo 2	Plate showing remaining vegetation
Orientation	NE	Orientation	N
Date	6/18/19	Date	6/18/19

No further corrective action is recommended. Wetland plants remain in the impacted area and the wetland hydrology is unchanged. Wetland soils were present under the 2 to 5 inches of sediment deposited in the impacted area and the hydric soil conditions should re-establish over time. More impact to the wetland may occur through any corrective action requiring excavation and should be avoided.

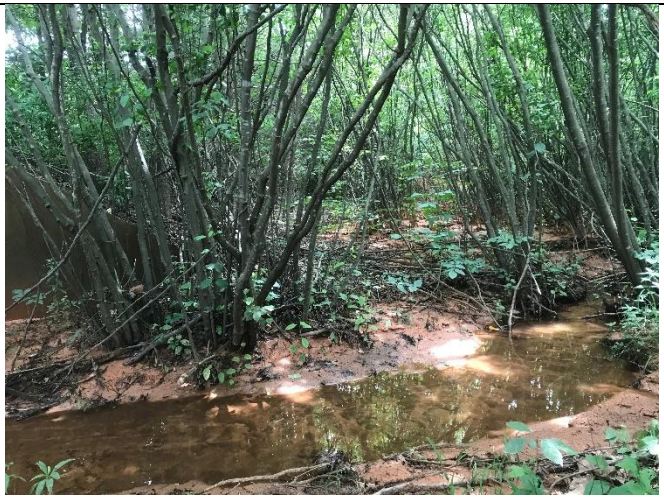
Photo 3	View of the impacted stream	Photo 4	View of slope impacted
Orientation	N	Orientation	S
Date	6/18/19	Date	6/18/19

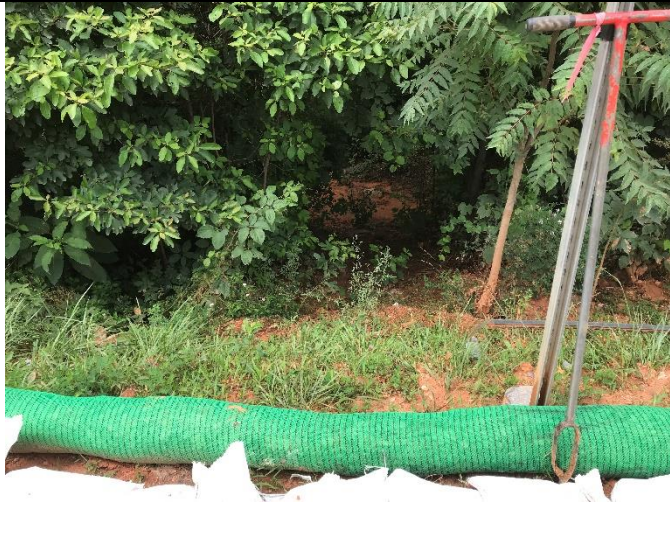
Photo 5	View of impacted slope	Photo 6	Plate showing impacted depth
Orientation	N	Orientation	N
Date	6/18/18	Date	6/18/19
