**VIRGINIA DEPARTMENT OF ENVIRONMENTAL QUALITY**

**WARNING LETTER**

Re: Region 2000 Landfill – Livestock Road Facility – 361 Livestock Road, Rustburg, VA  
Solid Waste Permit (SWP) 610

# Compliance Inspection Report

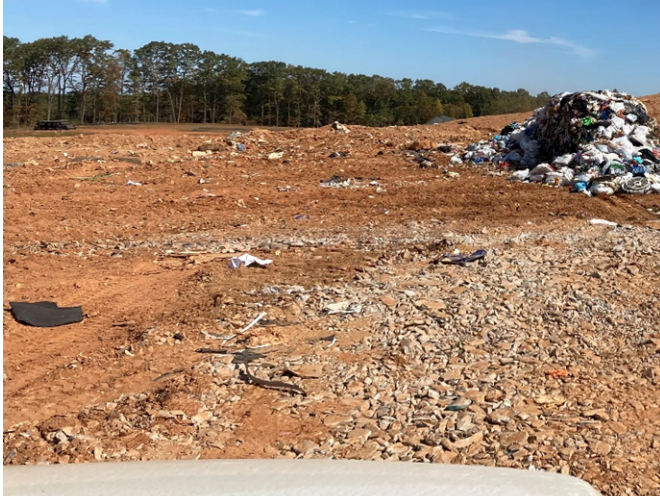
At the time of the inspection, the facility was operating a working face at the eastern area of Phase IV landfill. Some exposed solid waste was observed through the daily soil cover.

2. *Observations:* At the time of the inspection, the facility was operating a working face at the eastern area of Phase IV landfill. Some exposed solid waste was observed through the daily soil cover. Six inches of daily cover or approved alternate daily cover should be applied on all exposed waste at the end of the operating day. Further, exposed solid waste was observed in areas under intermediate cover. Additional soil cover should be added to the area to reduce the areas of exposed waste.

**c. Daily cover consisting of at least six inches of compacted soil or other approved material shall be placed upon and maintained on all exposed solid waste prior to the end of each operating day, or at more frequent intervals if necessary, to control disease vectors, fires, odors, blowing litter, and scavenging. Alternate materials of an alternate thickness may be approved by the department if it has been demonstrated that the alternate material and thickness control disease vectors, fires, odors, blowing litter, and scavenging without presenting a threat to human health and the environment. At least three days of acceptable cover soil or approved material at the average usage rate shall be maintained at the landfill or readily available at all times.**

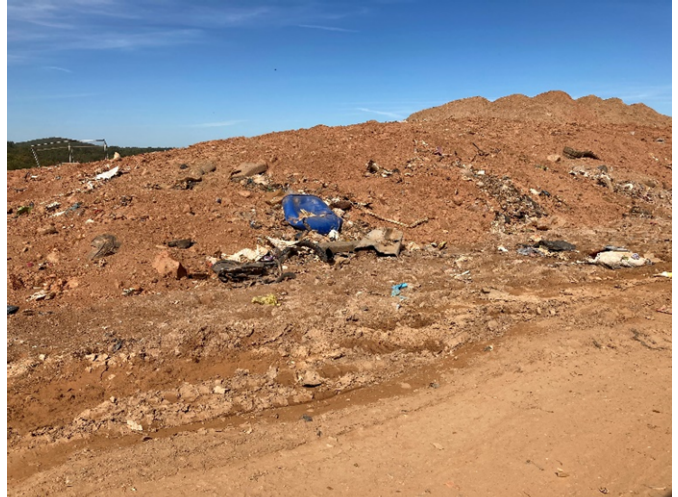
Exposed solid waste was observed in areas under intermediate cover.

**d. Intermediate cover of at least six inches of additional compacted soil shall be applied and maintained whenever an additional lift of refuse is not to be applied within 30 days. Further, all areas with intermediate cover exposed shall be inspected as needed, but not less than weekly. Additional cover material shall be**

**placed on all cracked, eroded, and uneven areas as required to maintain the integrity of the intermediate cover system.”**

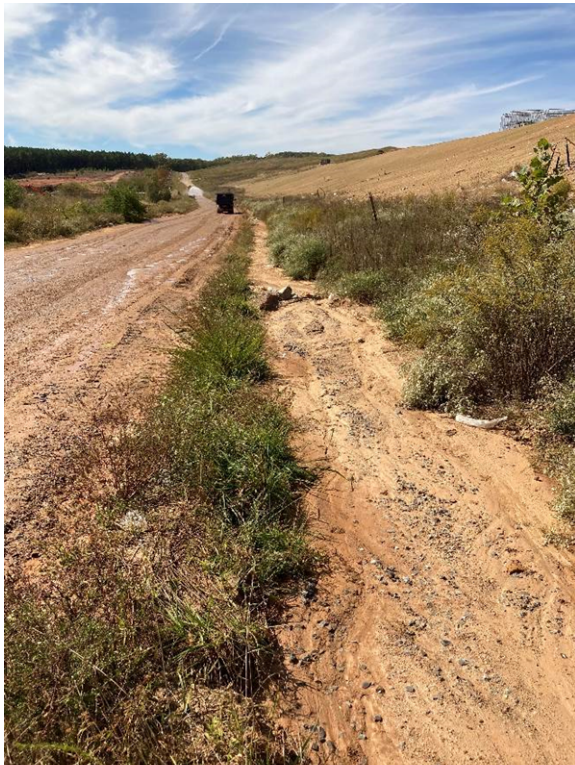
The stormwater perimeter ditches around the southern and southeastern Phase IV landfill were filled with sediment and not functioning as designed. The drainage ditches were not maintained to prevent flow onto the active portion of the landfill or to prevent ponding and erosion.

1. *Observations:* The stormwater perimeter ditches around the southern and southeastern Phase IV landfill were filled with sediment and not functioning as designed. The drainage ditches were not maintained to prevent flow onto the active portion of the landfill or to prevent ponding and erosion.

***Legal Requirements:* 9 VAC 20-81-140.A.7. states “Owners or operators shall maintain the run-on/runoff control systems designed and constructed in accordance with 9VAC20-81-130 H.”**

**9 VAC 20-81-130.H.3. states “Drainage structures shall be installed and continuously maintained to prevent ponding and erosion, and to minimize infiltration of water into solid waste cells.”**
